# GEOMORPHOLOGICAL IMPACTS

## of Channel Straightening in an Agricultural Watershed, Southwestern Québec

Yannick Rousseau and Pascale M. Biron  
Concordia University

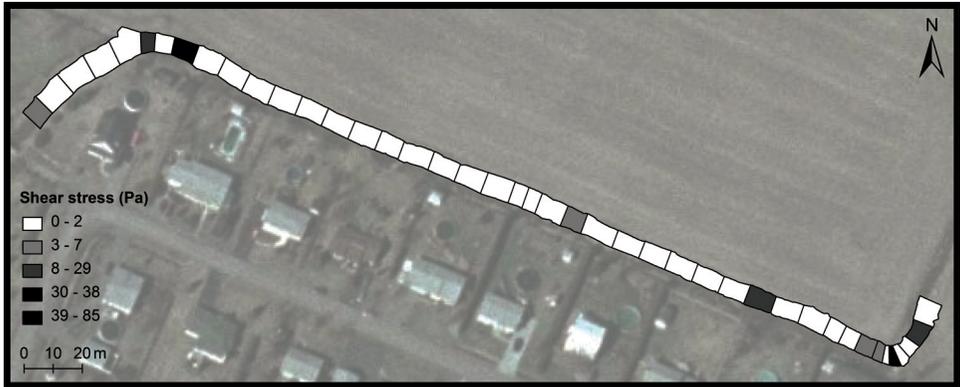
Figure 4. Estimated bed shear stress values in the residential reach. Flow is from left to right.

The analysis of individual cross-sections also revealed that bed shear stress distribution is not uniform in the residential reach (Figure 4). Although the average calculated bed shear stress is around  $4.0 \text{ N/m}^2$  in 2006, a twentyfold increase in estimated shear stress values is observed in the cross-sections immediately downstream of the two bends, suggesting a high potential to erode bend banks. High bed shear stress values are also visible upstream of the second bend which is a zone with a massive failure of the right bank that constricts the channel cross-sectional area.

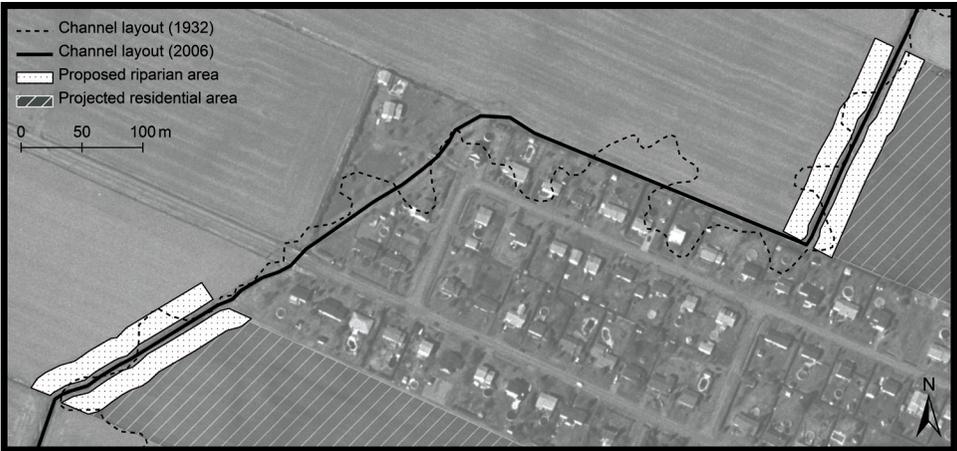
Figure 7. Potential solution consisting in the naturalization of two parts of the Richer channel that are located near future residential developments. The width of the riparian zone for the two proposed development is based on the natural (1932) meander amplitude for each zone.

inside its historical channel and ecosystem; this solution helps restore geomorphic features, diversity and functions quickly (Toth 1996). However, the Richer Stream cannot be relocated inside the 1932 channel in the residential area as the channel has been filled for agricultural purposes and as the municipality of Saint-Marc-sur-Richelieu was established over the former planform. Instead, the channel could be altered to exhibit historical stable planform, shape and dimensions, knowing that the resulting channel would also be relatively stable. Since the municipality of Saint-Marc-sur-Richelieu was planning to expand its residential area next to the river (upstream and downstream), a naturalization solution was proposed to its Administration Council in January 2008 to prevent eventual land losses and damages to infrastructure and future dwellings, and environmental degradation associated with dredging practices. Using aerial photographs, it was estimated that the historical stable channel-pattern amplitude (exhibiting negligible lateral or downstream migration rates and having a 10-m wide channel) occupied a zone with an amplitude of 44 and 42 m upstream and downstream of the residential area, respectively. A suggestion was thus made to use 17- and 16-m wide riparian areas on both sides of the stream respectively for the northern and southern development sites (Figure 7). These values correspond to the amplitude less the channel width (10 m), divided by two. Although it was felt that leaving such a corridor undeveloped would limit future needs for stabilization and notwithstanding that no long-term comparison of costs was completed, this solution was rejected by the council for financial reasons. Instead, the administration council maintained their idea of establishing a 13-m wide corridor, which is 3 m larger than what is required by the provincial law.

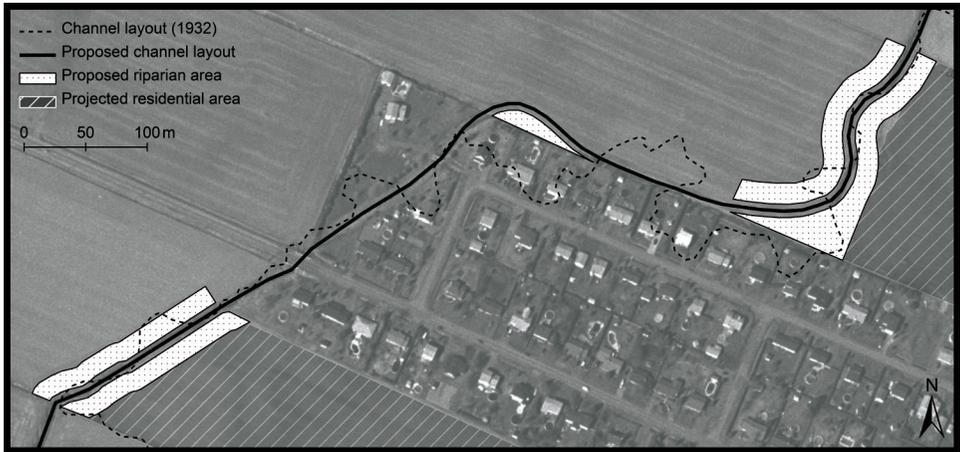
Figure 9. Potential solution relying on planform and shape alterations, stabilization with vegetation and bioengineering techniques, and naturalization.

An intermediate solution consists in combining the establishment of a riparian vegetated strip and minor planform and shape modifications (Figure 9). The curved planform in the area downstream of the residential area decreases flow impact at the location where bed shear stress values were estimated to be the highest. The riparian areas stabilize banks and provide the channel with enough space to adjust laterally.
